Manhole Inspection Summary

Manhole # S39WW_046MH

Location Address: **919 HOMESTEAD ST**

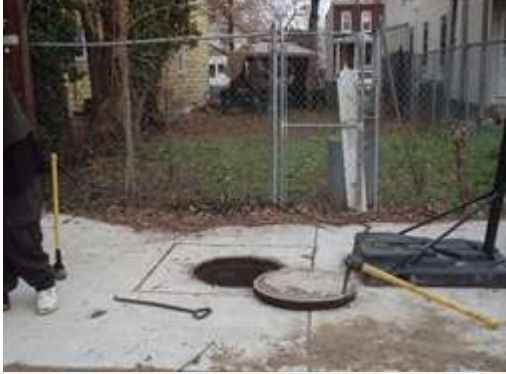
Location View

Comments **Located in an alley under a basket ball rim. It was covered with cement.**

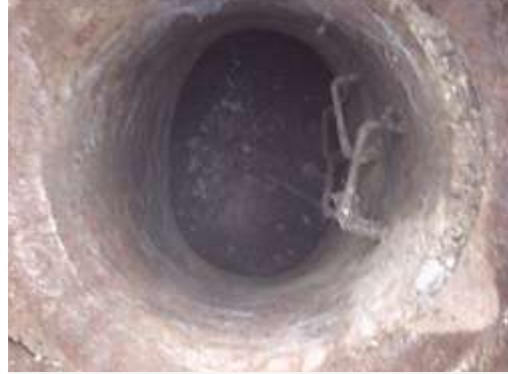
Top View

Corroded steps. Channel debris.

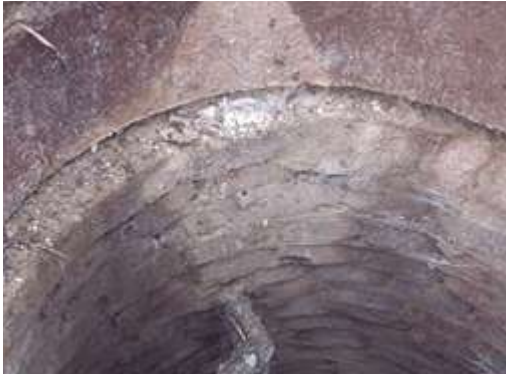
Defect

Frame leaks. Frame offset. Adjustment deterioration and infiltration. Corbel infiltration.

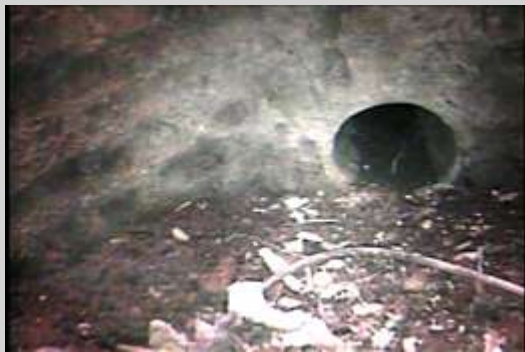
8 in. Circular Gravity Sewer
Pipe Out @ 12 O'Clock

Barrel infiltration.
